Lineman Electrical Contact
Grant Co. PUD
Accident Report
January 22, 2017

Reported by
Rodney Fronsman
Accident Investigator
Local 77

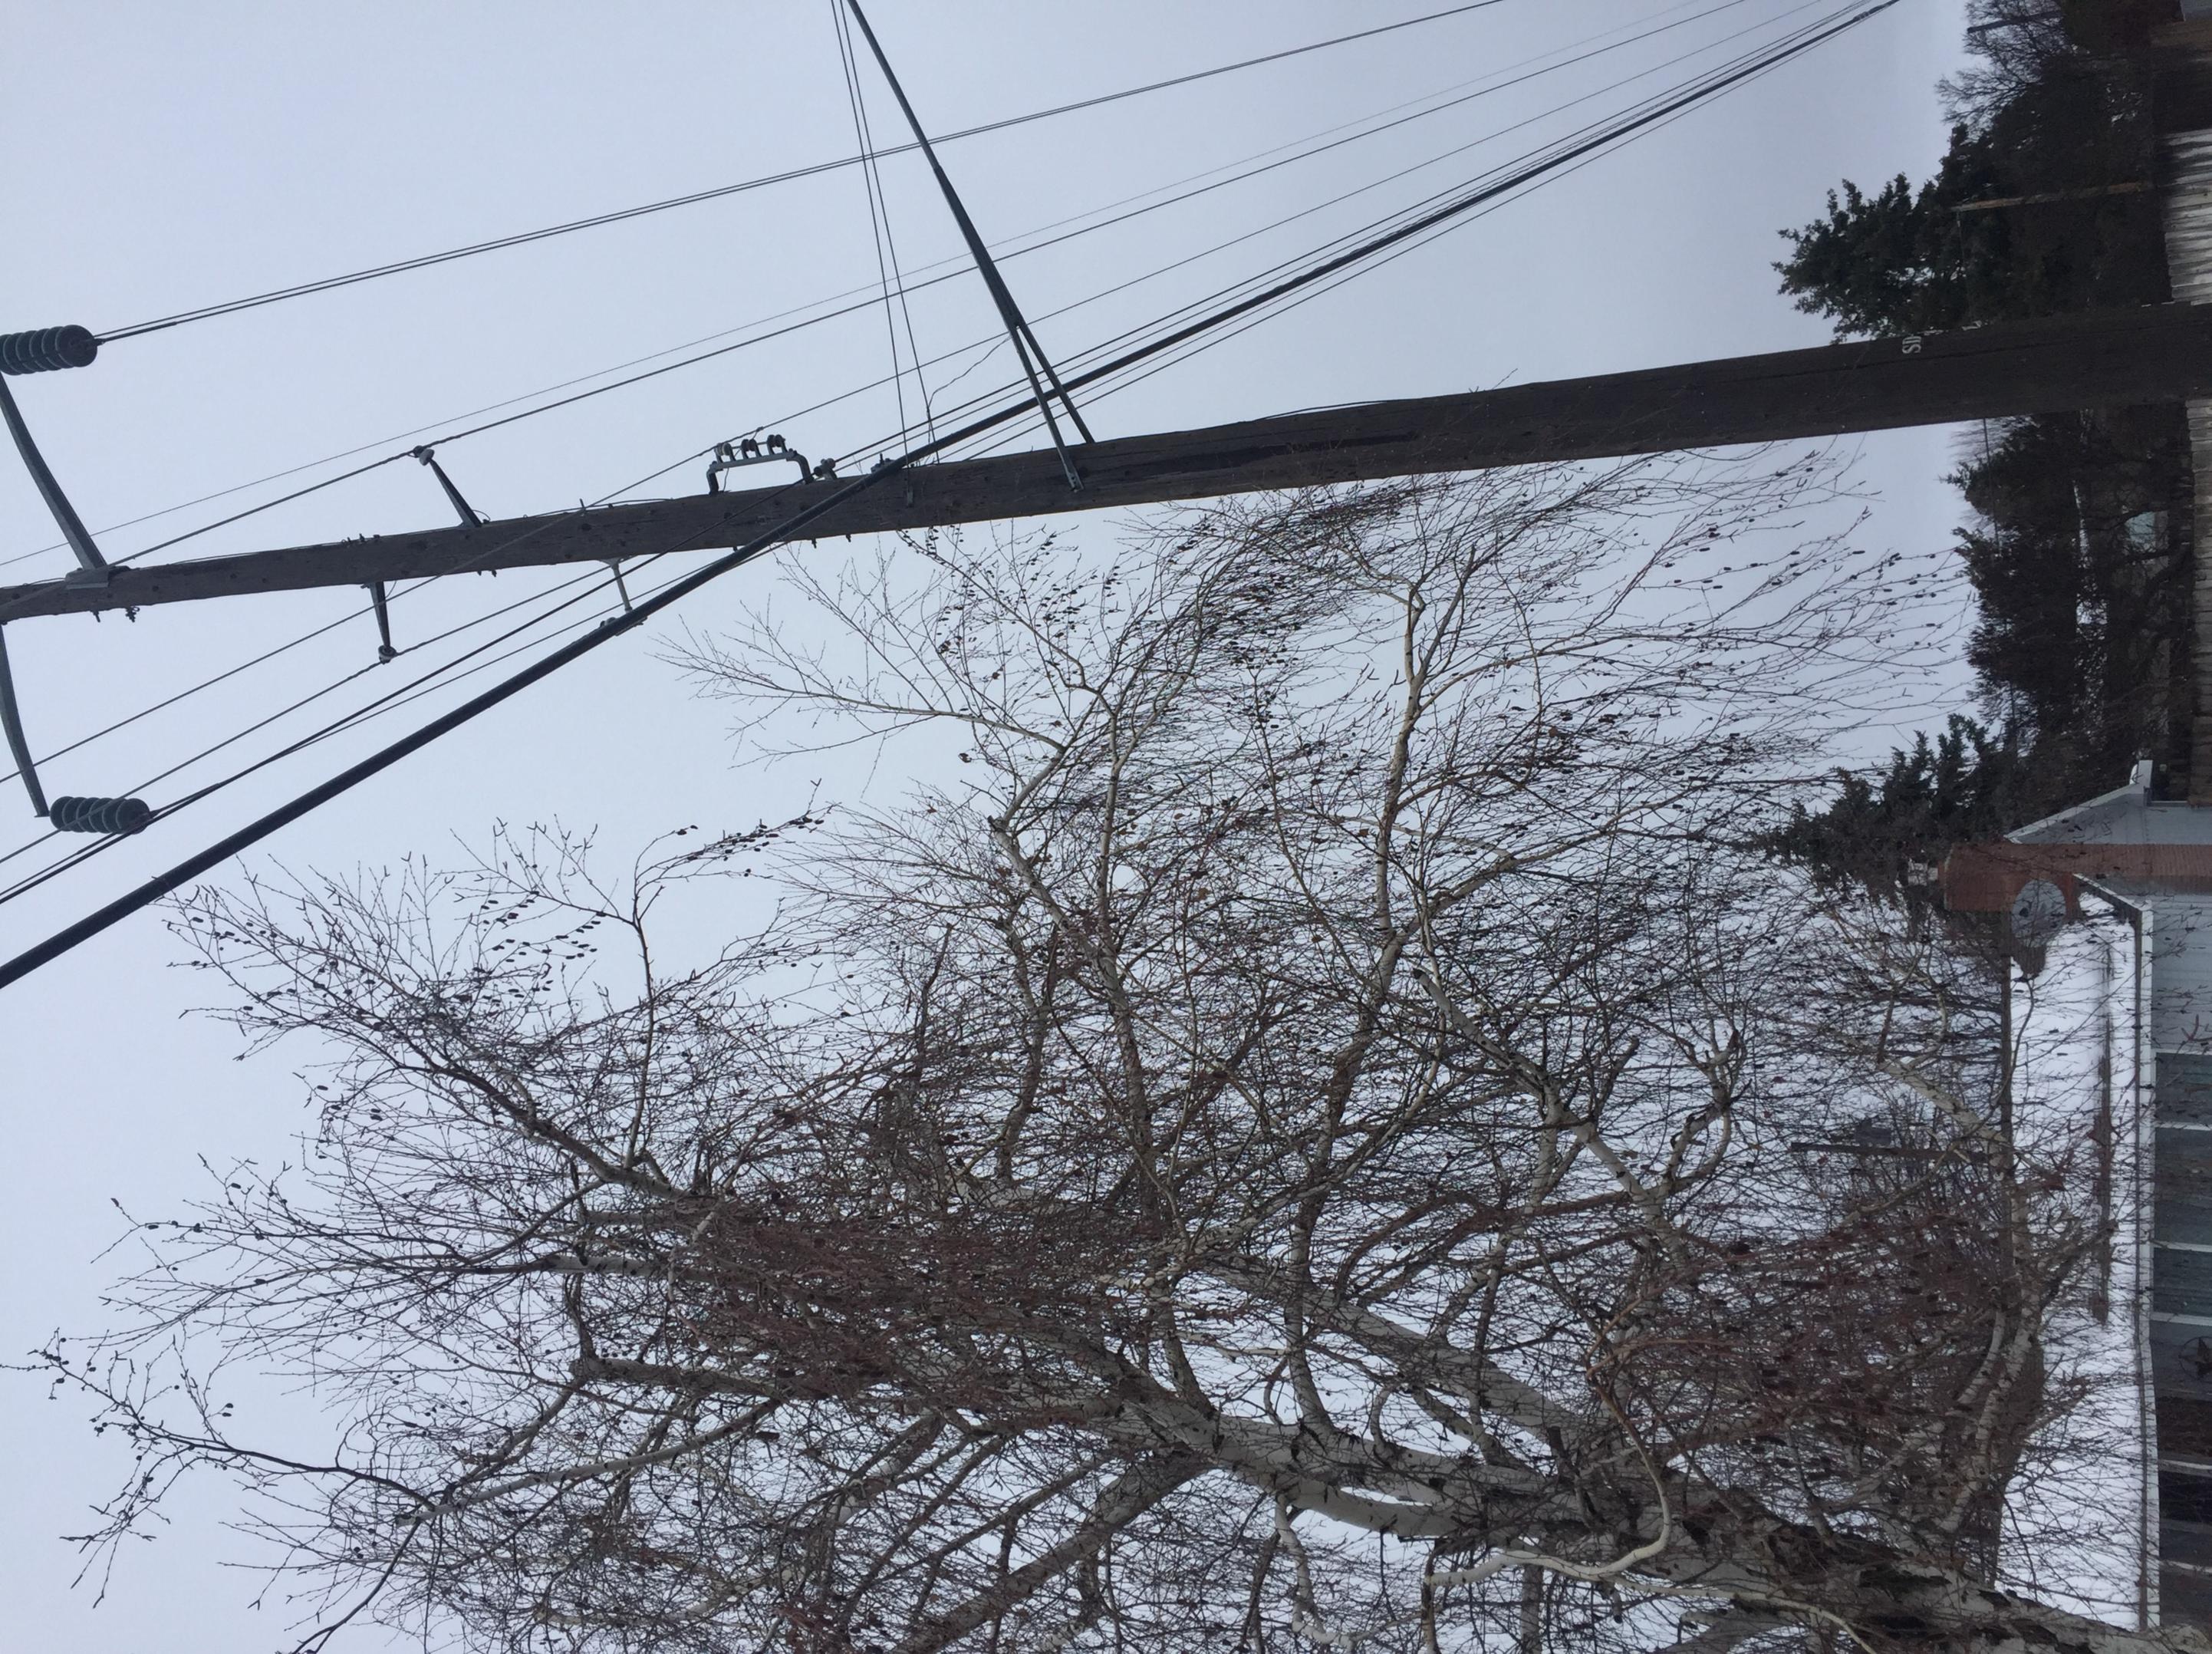
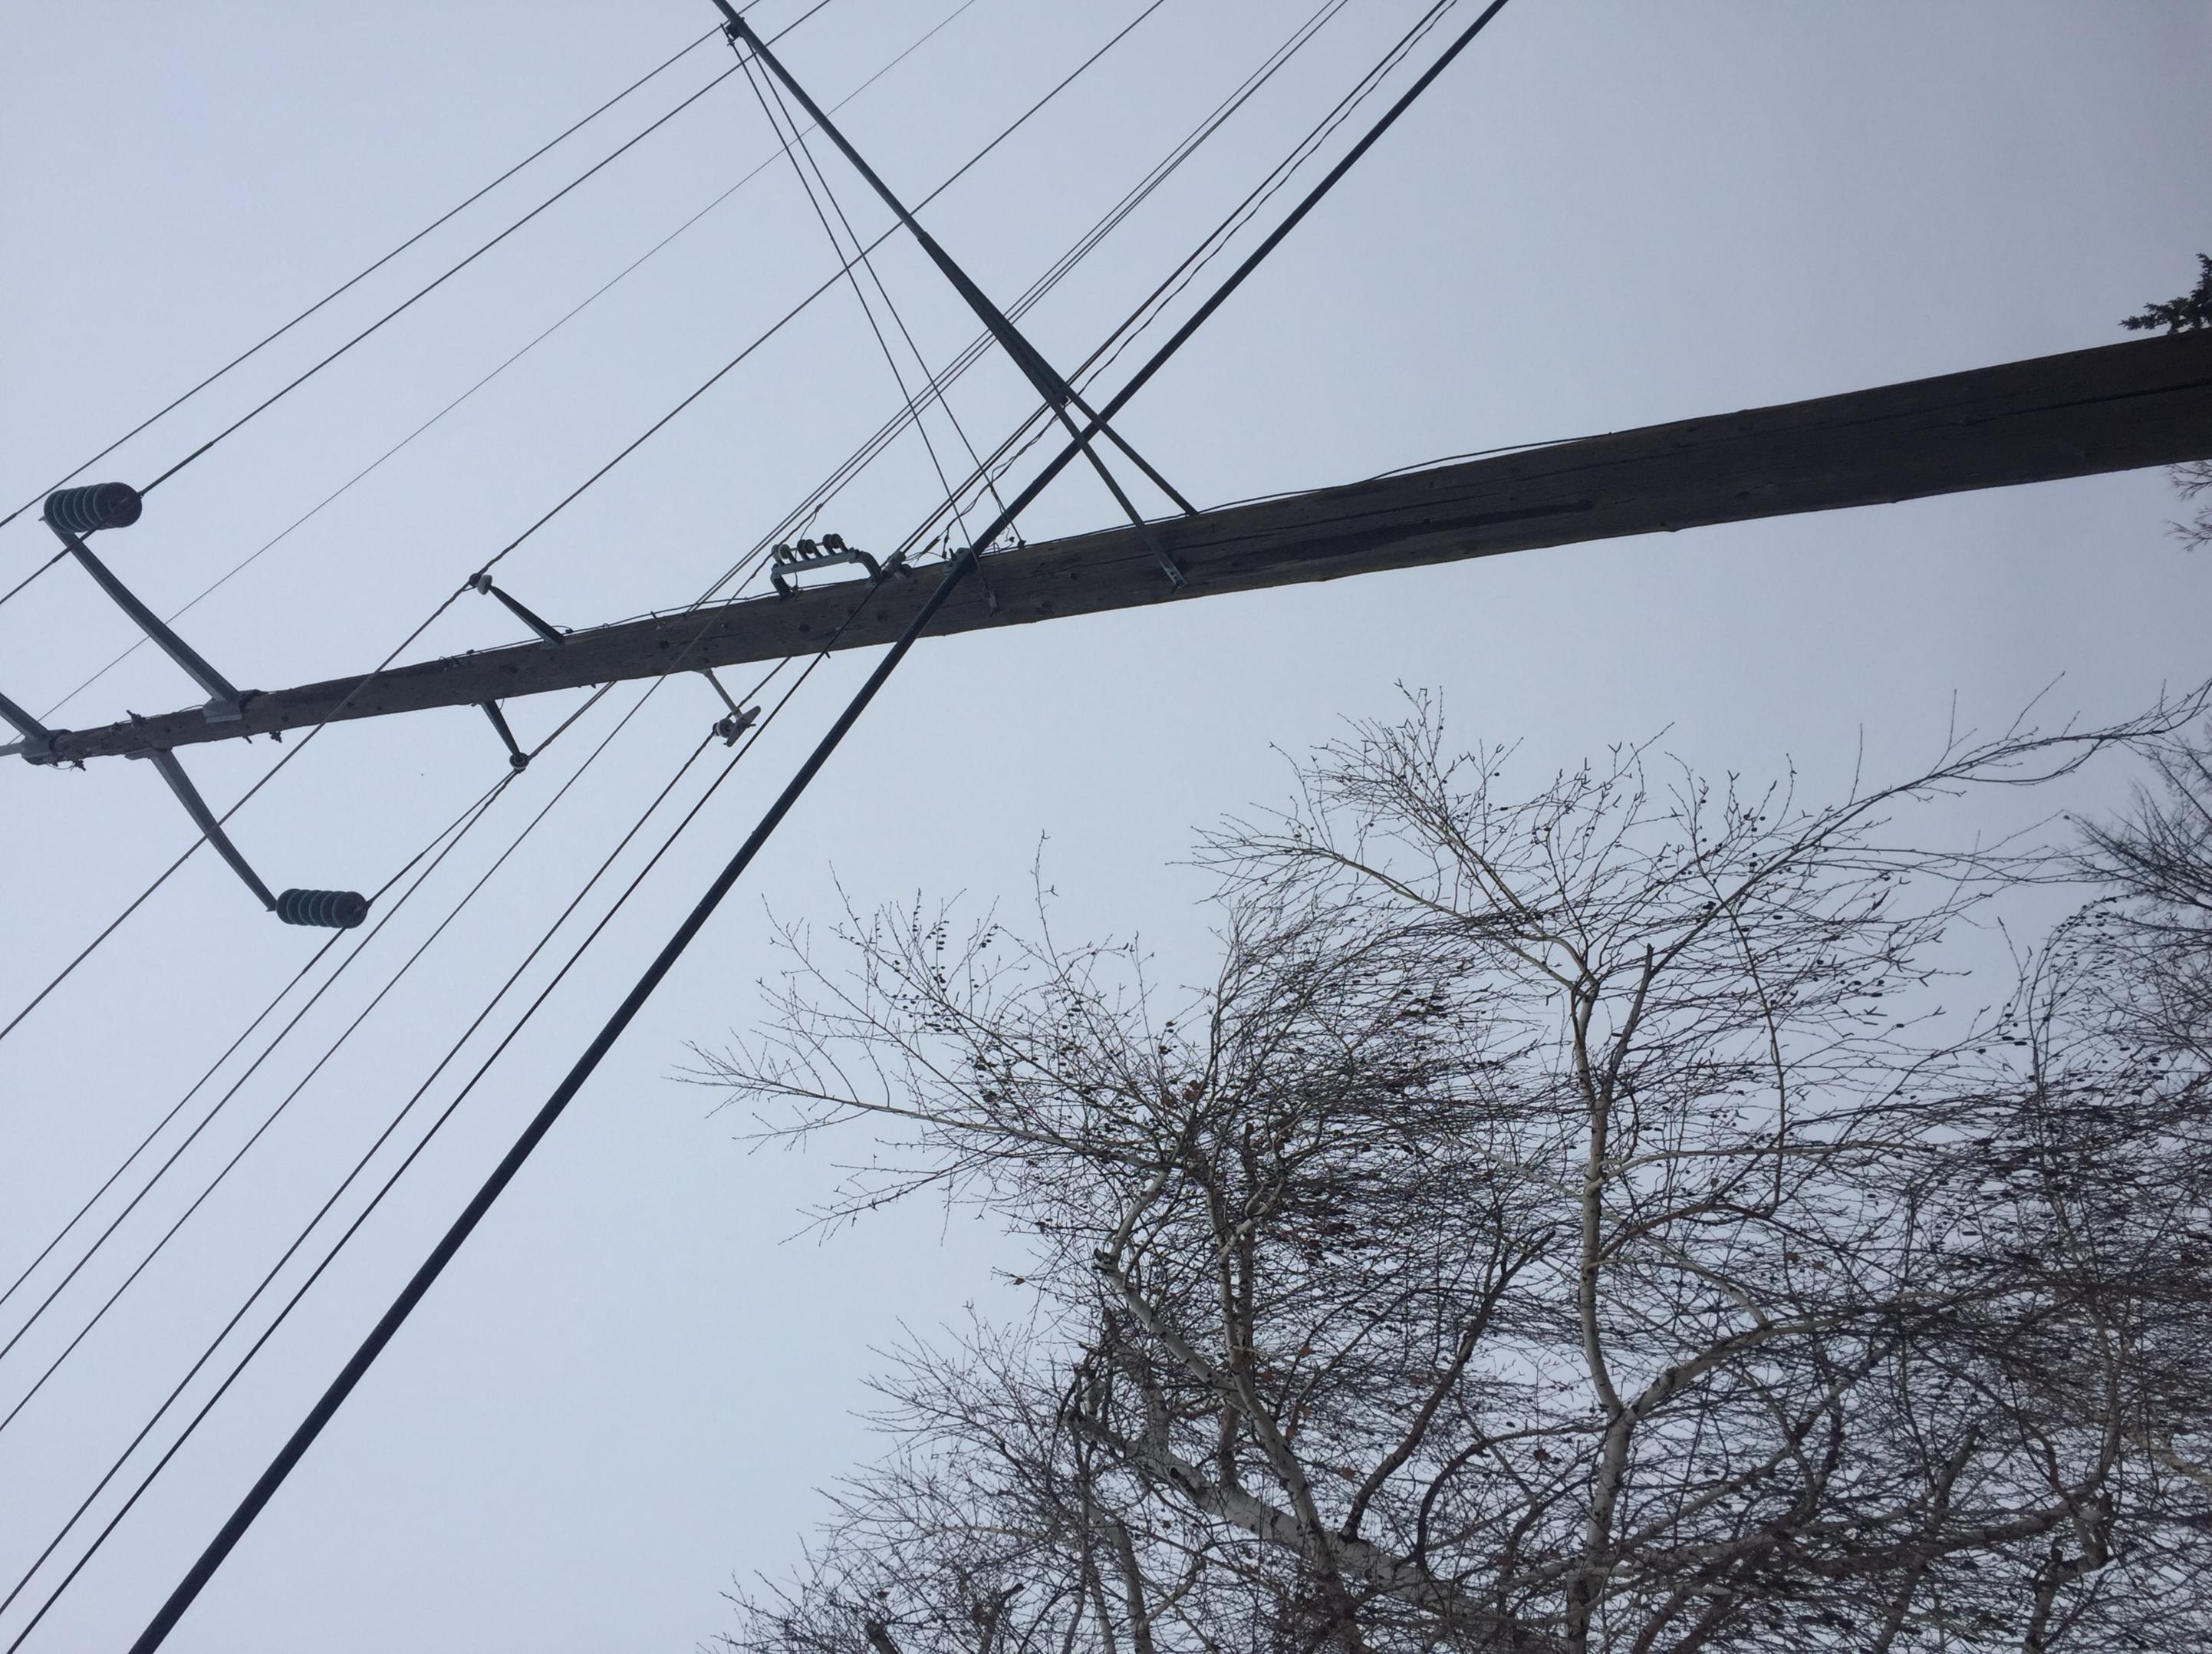
A trouble report from Grant dispatch was created for a street light sparking. Two linemen responded to trouble report and found the lower distribution line floating in a tree. The pole construction was a highline pole with distribution underbuild (336 wire) small construction. Pole to the south was also a highline pole with an 8 foot wood arm for the distribution. Pole to the north was identical construction to the pole with floating phase. Lineman then called dispatch to report problem and have two more called out to create a crew. Also, a hot line hold was issued for the acting foreman. At 9:15 pm two linemen had arrived to assist and take care of the issue. A job brief was conducted, also discussed in job brief was that the trucks would be set up back to back. Two linemen (A & B), would work out of the two man bucket truck which was facing north, and one lineman (C) would be in the one man service truck facing south. The other lineman (D) would be the safety watch from the ground and acting foreman.

Lineman A and B flew up to change out old twiggy arm and glass where the phase had fallen from. Once things were finished, lineman C was to get underneath the phase with a pig tail stick and bucket to fly phase closer to the twiggy arm and glass. Lineman A and B would then secure and take the phase up the rest of the way (Lineman C would only be able to fly the wire so far up due to bucket/boom being under communication wires.) Lineman C flew wire to the other lineman A and B as far as he could and stopped a couple feet from the glass. Lineman A and B then secured wire with two pigtail sticks. Then a three way discussion took place that they needed to take remaining old wrap lock tie off before placing onto glass. Lineman A and B both removed sticks from the wire to grab a ring stick to get wrap lock off. At that time, lineman C shifted and began losing control of wire due to weight and some side strain. The weight and strain was enough to pull hot stick away from lineman C in the bucket and stick was pinned to the bucket floor. Lineman C was now straddling the hot stick. It brushed the back of the bucket and lifted him out of the bucket, ejecting him out, flipping forward. Lineman C was now dangling from his harness between the pole and tree. Lineman D (foreman) who was on the ground immediately jumped onto service truck to run lower controls. Lineman D was able to maneuver him clear of lines and bring him to a safe place where linemen A and B could come underneath him and place him in their bucket. Lineman C was conscious and rescued to the ground with no serious injuries. Crew members mentioned that he did come in contact with energized phase. Lineman C was evaluated and taken to hospital for observation and was released later that night.
