# **DOUGLAS COUNTY PUD**

## **ACCIDENT**

**JULY 23, 2011**

**INVESTIGATED AND REPORTED BY IBEW LOCAL 77's**

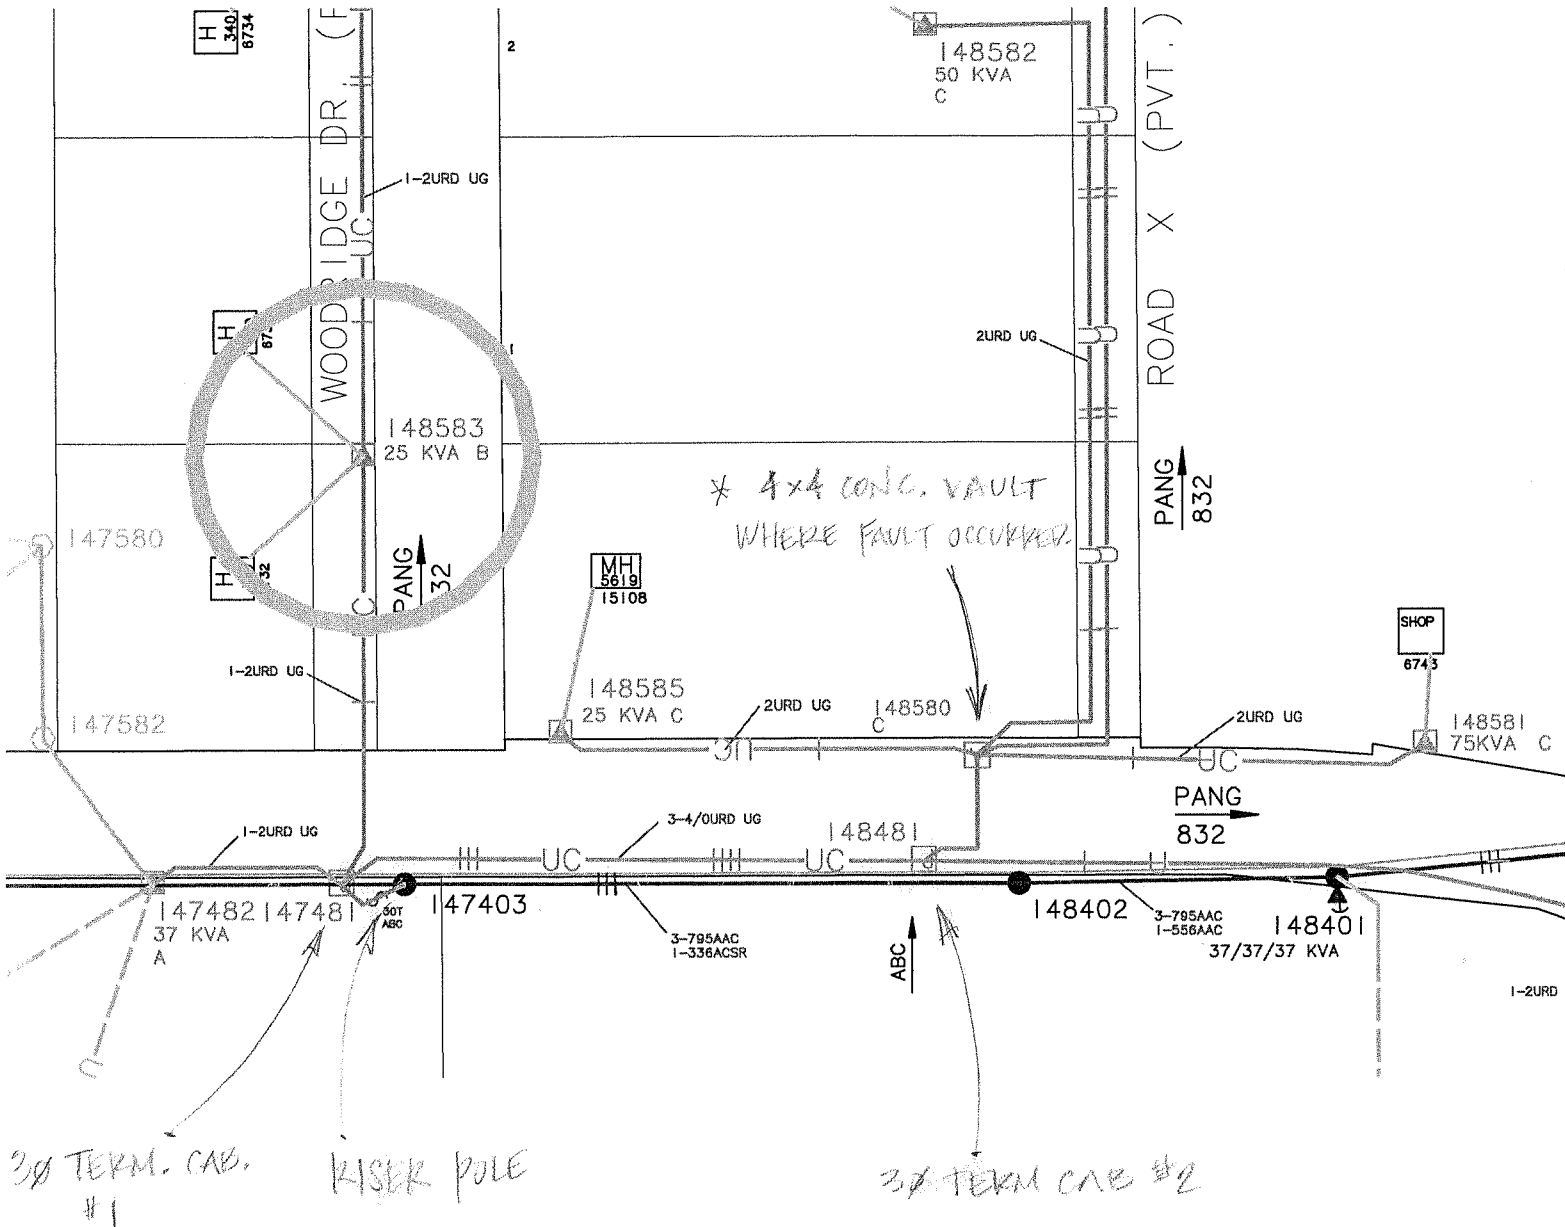
SYSTEM MAP - THIS VERSION WAS FROM THE CORRECTED VERSION DONE AFTER THE ACCIDENT. NO COPIES OF INCORRECT MAPS ARE AVAILABLE.
