05-18-2009

Inland Power and Light Accident

May 18, 2009

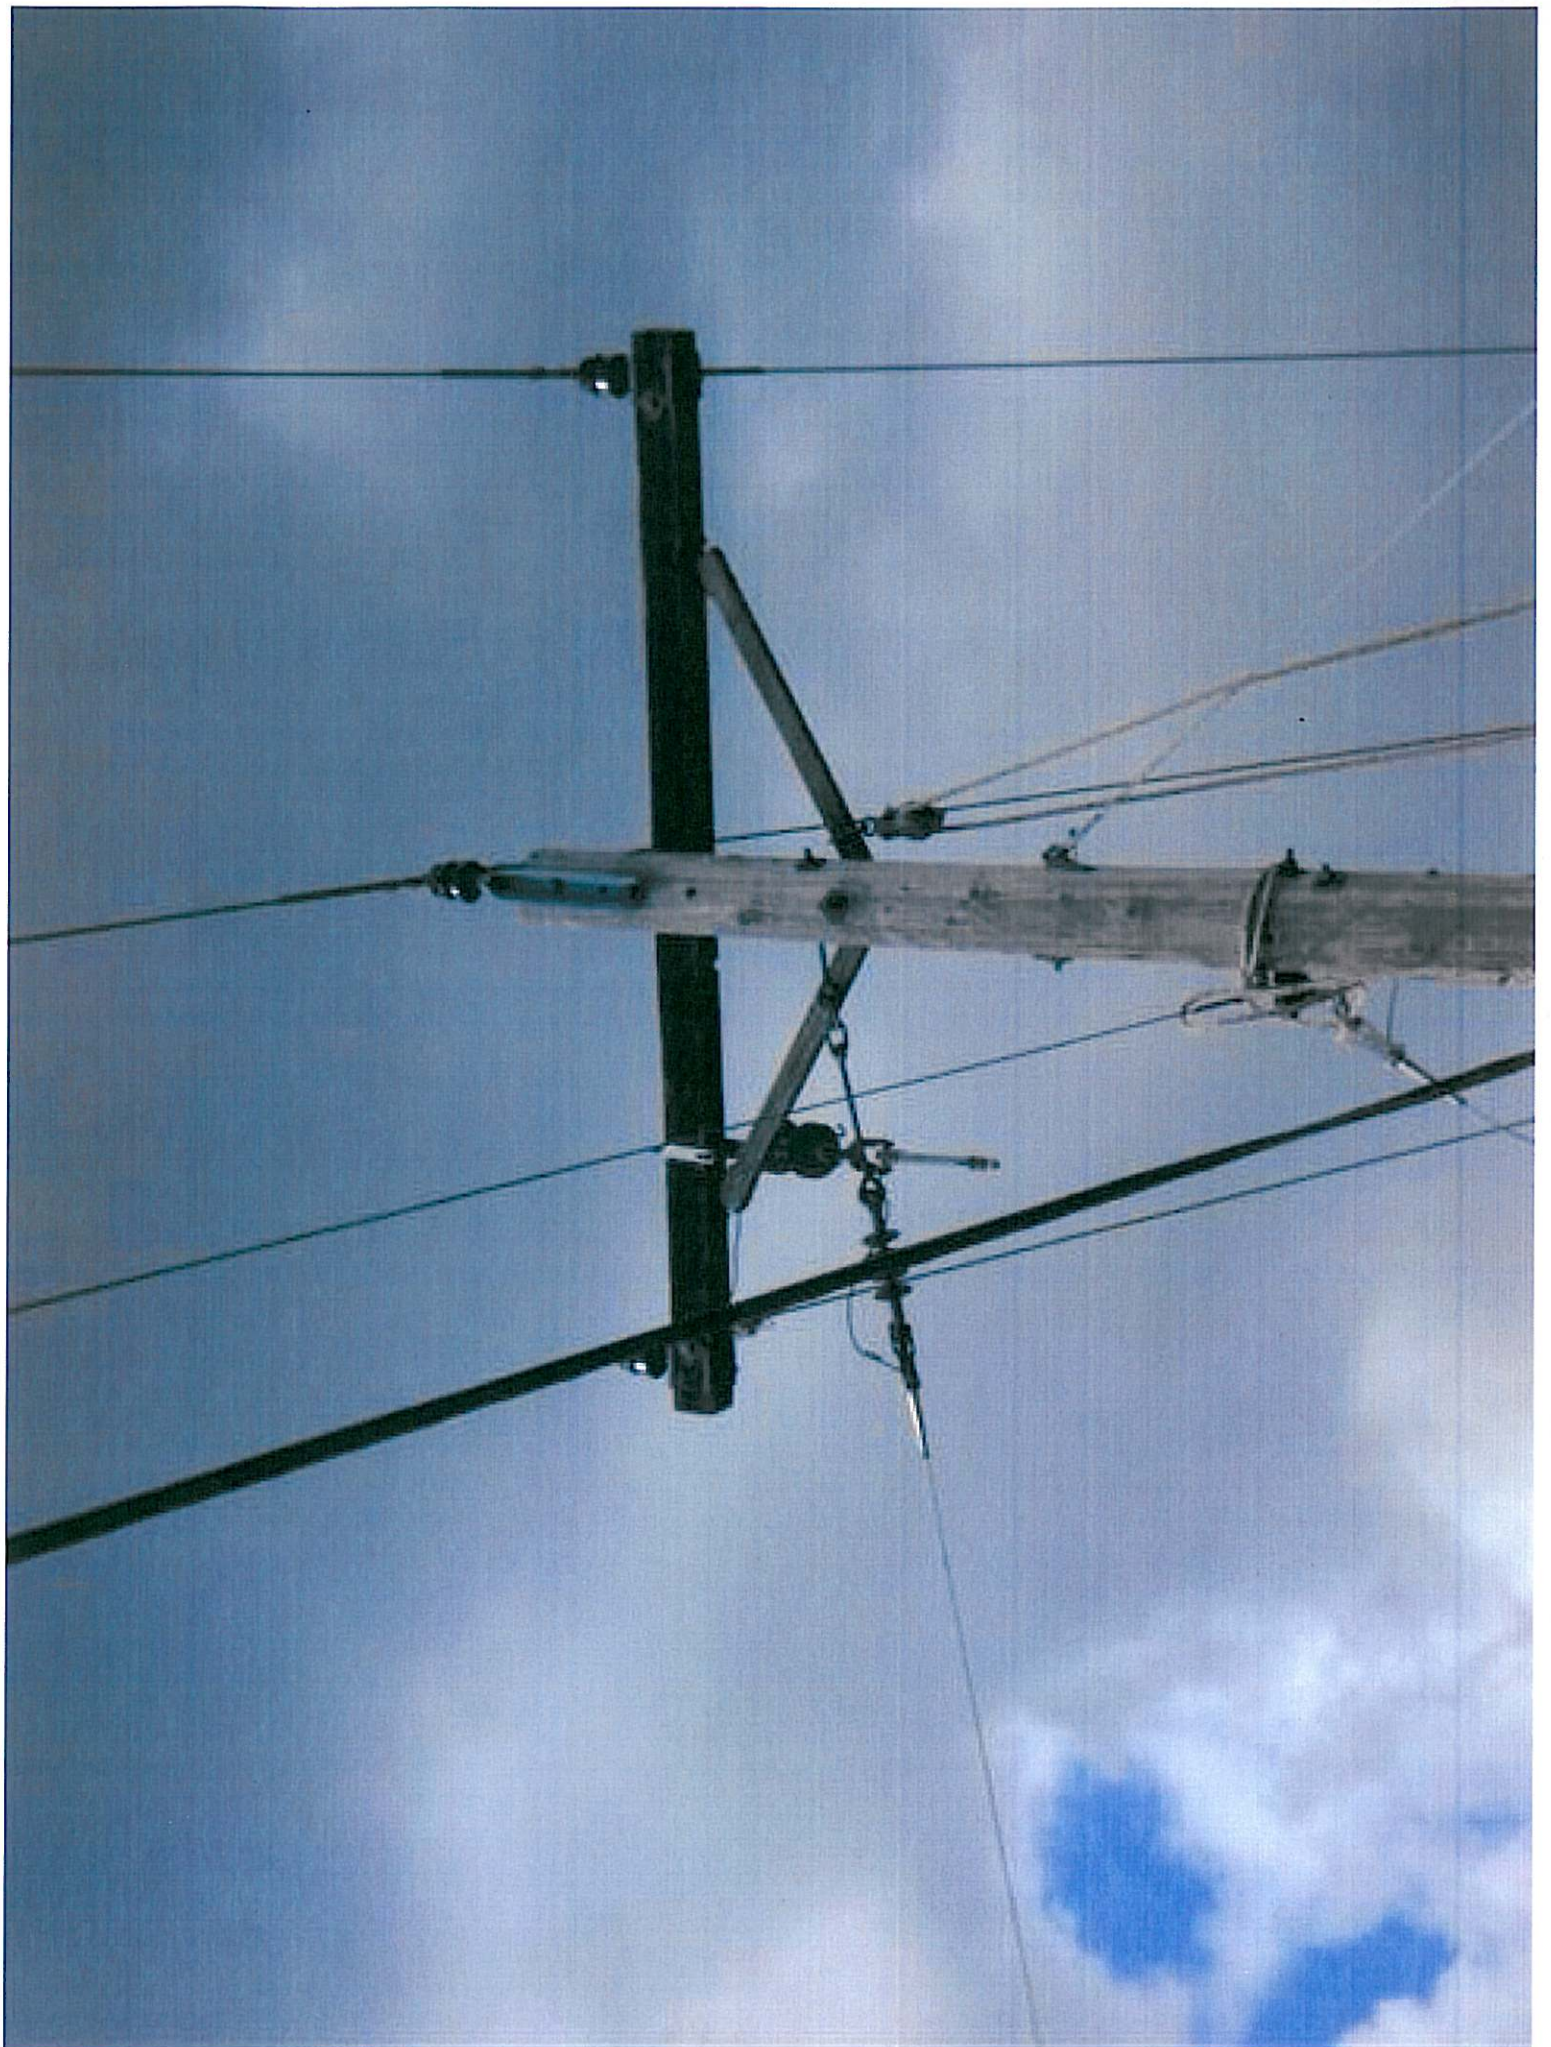
Following the tailboard discussion, the apprentice climbed the pole and positioned himself at the neutral level and then cut down the broken neutral leaving enough tail to sleeve back on to. As an afterthought, discussed by the journeyman and apprentice, the phase needed to be higher in order for the neutral to have road clearance. As a result, the apprentice then climbed up and belted in below the down guy attachment and below the single phase dead end hardware. The hand line remained at the neutral level. (See attached photo)

The apprentice began to tighten the primary dead end bolt to tighten sag on the phase. This motion turned the dead end bolt. As a result, the energized load side cutout jumper twisted and energized the bolt. The apprentice received a hand to hand electrical contact and said to the journeyman, "I've been hit." before collapsing.

Upon investigation, burn marks were observed on the apprentice's right glove and channel locks. A crescent wrench was also lying at the base of the pole with no visible burn marks. A second point of contact has not been established.

1. Two men when working within MAD.
2. Ensure adequate manpower for job.
3. Open cutout to eliminate hazard of neutral return current.
4. Open cutout to eliminate minimum approach distance hazard.
5. Eliminate hazards before performing rescue.
