MASS ELECTRIC

ACCIDENT

FEBRUARY 25, 2008

Investigated and Reported by
Jeff Baker
IBEW Local 77 Accident Investigator

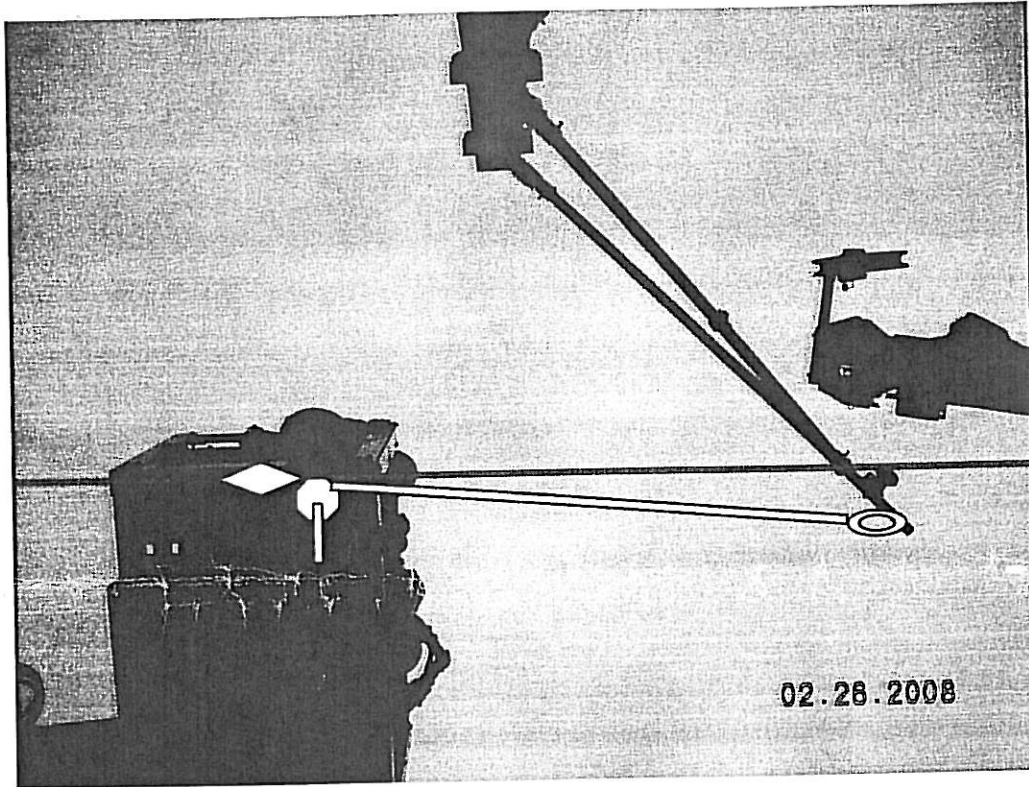
In the type of work being performed at the time of the accident the crew's job was to go up and sag the messenger cable bringing them up to proper tension for installation by using a hoist and a cantilever on an outside radial load curved section of the track. Two of the lines were brought up to about 8,500 lbs and due to the angle of the messenger wire it caused the arm to rack (see picture #1) when the third messenger line was at about 6,800 lbs (see picture #2).

Contributing Factors: Contributing to this incident was the tensioned messenger cable not being secured prior to loosening the insulator clamp and using the man lift as a tool to rack the arm.

Prevention: To prevent this from happening in the future, the company has instituted procedures that require the messenger wire be secured by boom and traveler rigging, an engineered jib for outside radial curved track cantilever adjustment, or the Palfinger hydraulic grabber and that no piece of equipment be used directly in contact with the messenger wire.

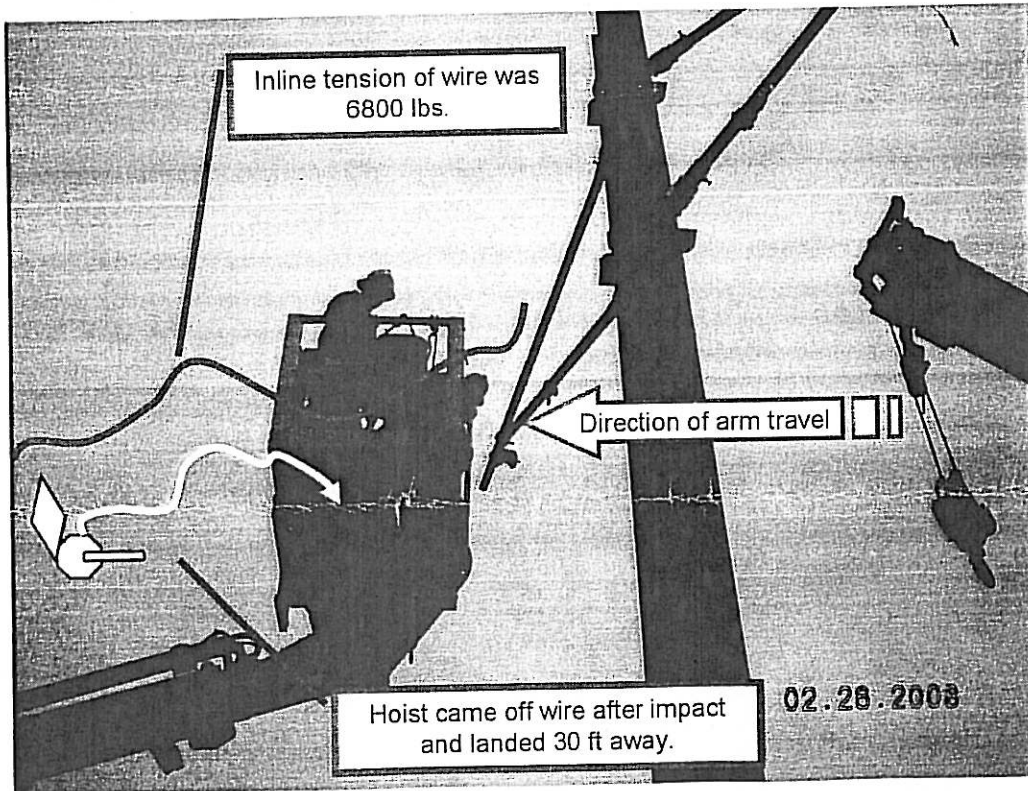
There was a rigging failure that led to the Lineman being knocked unconscious and suffering cuts and bruises to the head and neck area. The first step Apprentice was knocked off the platform (see picture #3) which was positioned approximately 25-30 feet in the air (see picture #2). Both men were properly wearing PPE equipment including a harness that arrested the fall when the Apprentice was ejected.

The Lineman positioned the man lift to apply load to the messenger wire approximately 8 inches away from an insulator clamp and arm when the tensioned messenger wire came out of the clamp, it pinched between the boom and separated, causing the chain hoist and cantilever to come loose, impacting the workers, and landing 30 feet away (see picture #2).
