Wilson Construction
Electrical Contact
Accident Report
October 8, 2019

Rick Luiten
Accident Investigator
Local 77

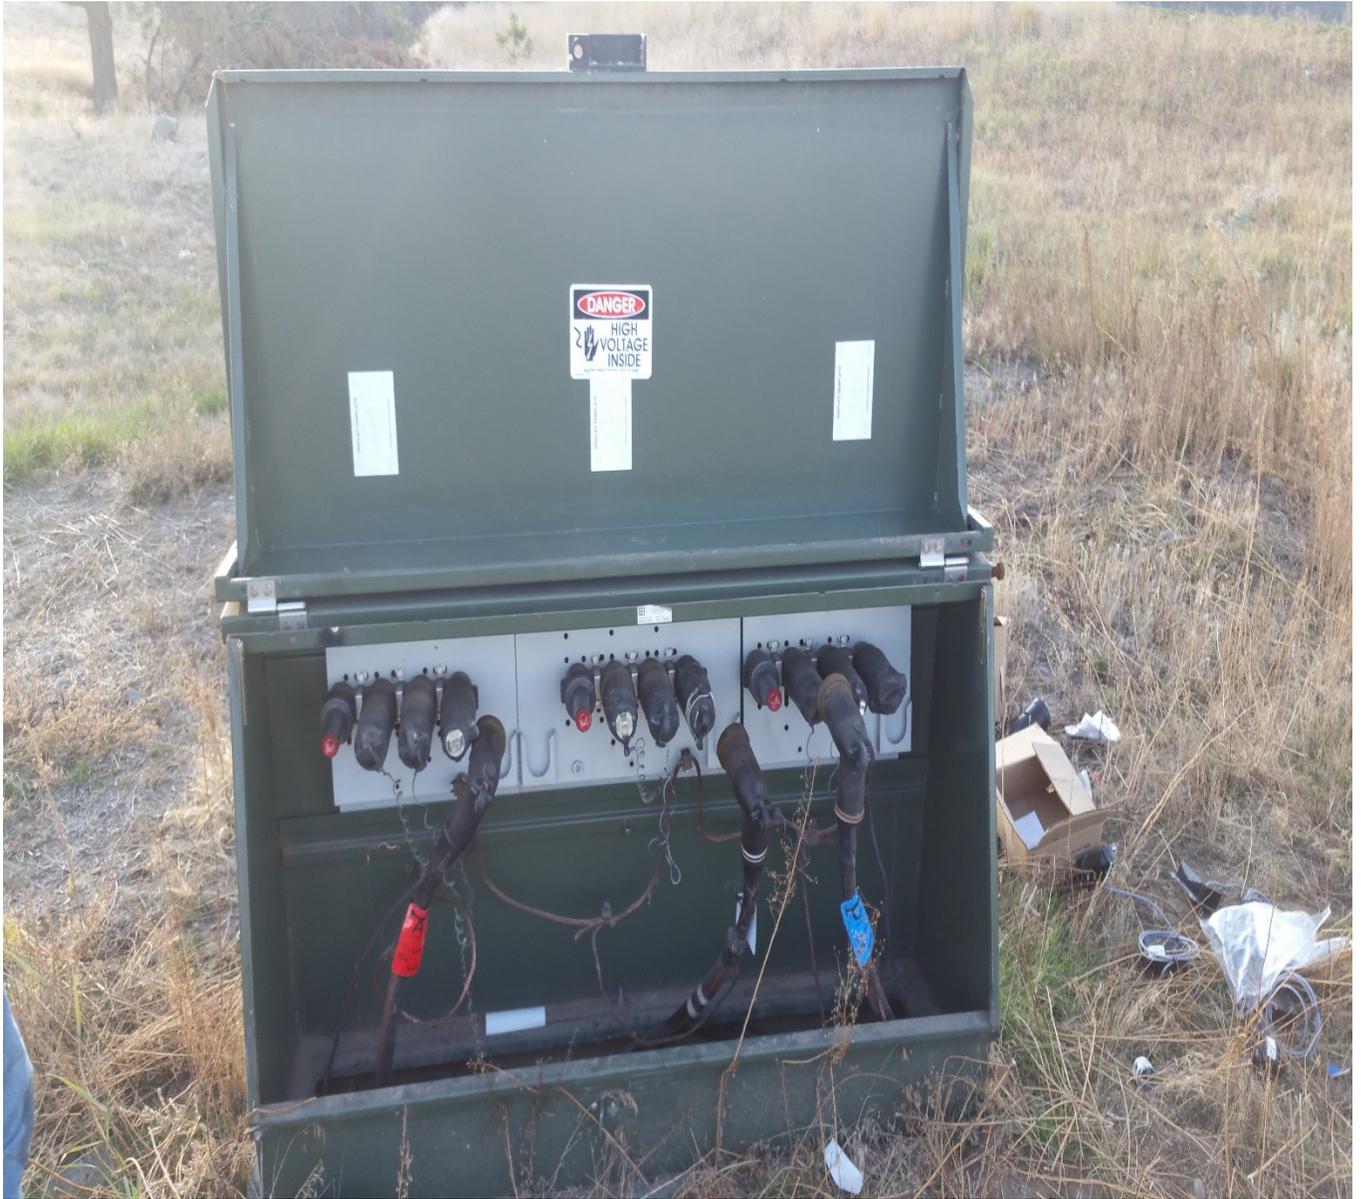
Once the Journeyman and the Apprentice arrived at junction enclosure #3 and prior to commencing the work, the Apprentice informed the Journeyman that the Foreman instructed them to use the grounded elbow. The Journeyman elected not to use the ground based on the information he received from the Foreman that the cable was deenergized and the fact the crew had no insulated live line tools on site to install the protective ground. Once the cabinet was opened, the Journeyman removed all three elbows by hand from their insulated/isolation points (four ways). The Journeyman then kneeled on the ground in front of the junction enclosure, took the A phase elbow by hand and touched the end of the elbow probe on the concentric ground in the junction enclosure. He then inserted by hand a metal ratcheting probe tool into the elbow where it made contact with the non-insulated portion of the elbow probe that was energized at 7200 volts. He received a high voltage contact and was knocked backwards losing his grip on the elbow and probe tool. The probe tool still inside the elbow then contacted the grounded junction enclosure creating an arc. The probe tool still in the elbow then came to rest on the insulated portion (tip) of elbow probe and the junction enclosure.

Site of Accident - Three phase Junction Enclosure #3

- Follow all safe work practices, Identify, Isolate, Test and Ground
- Always use proper testing equipment, live line tools and grounds for task at hand
- Immediately call emergency services (911) in the event of any high voltage contact

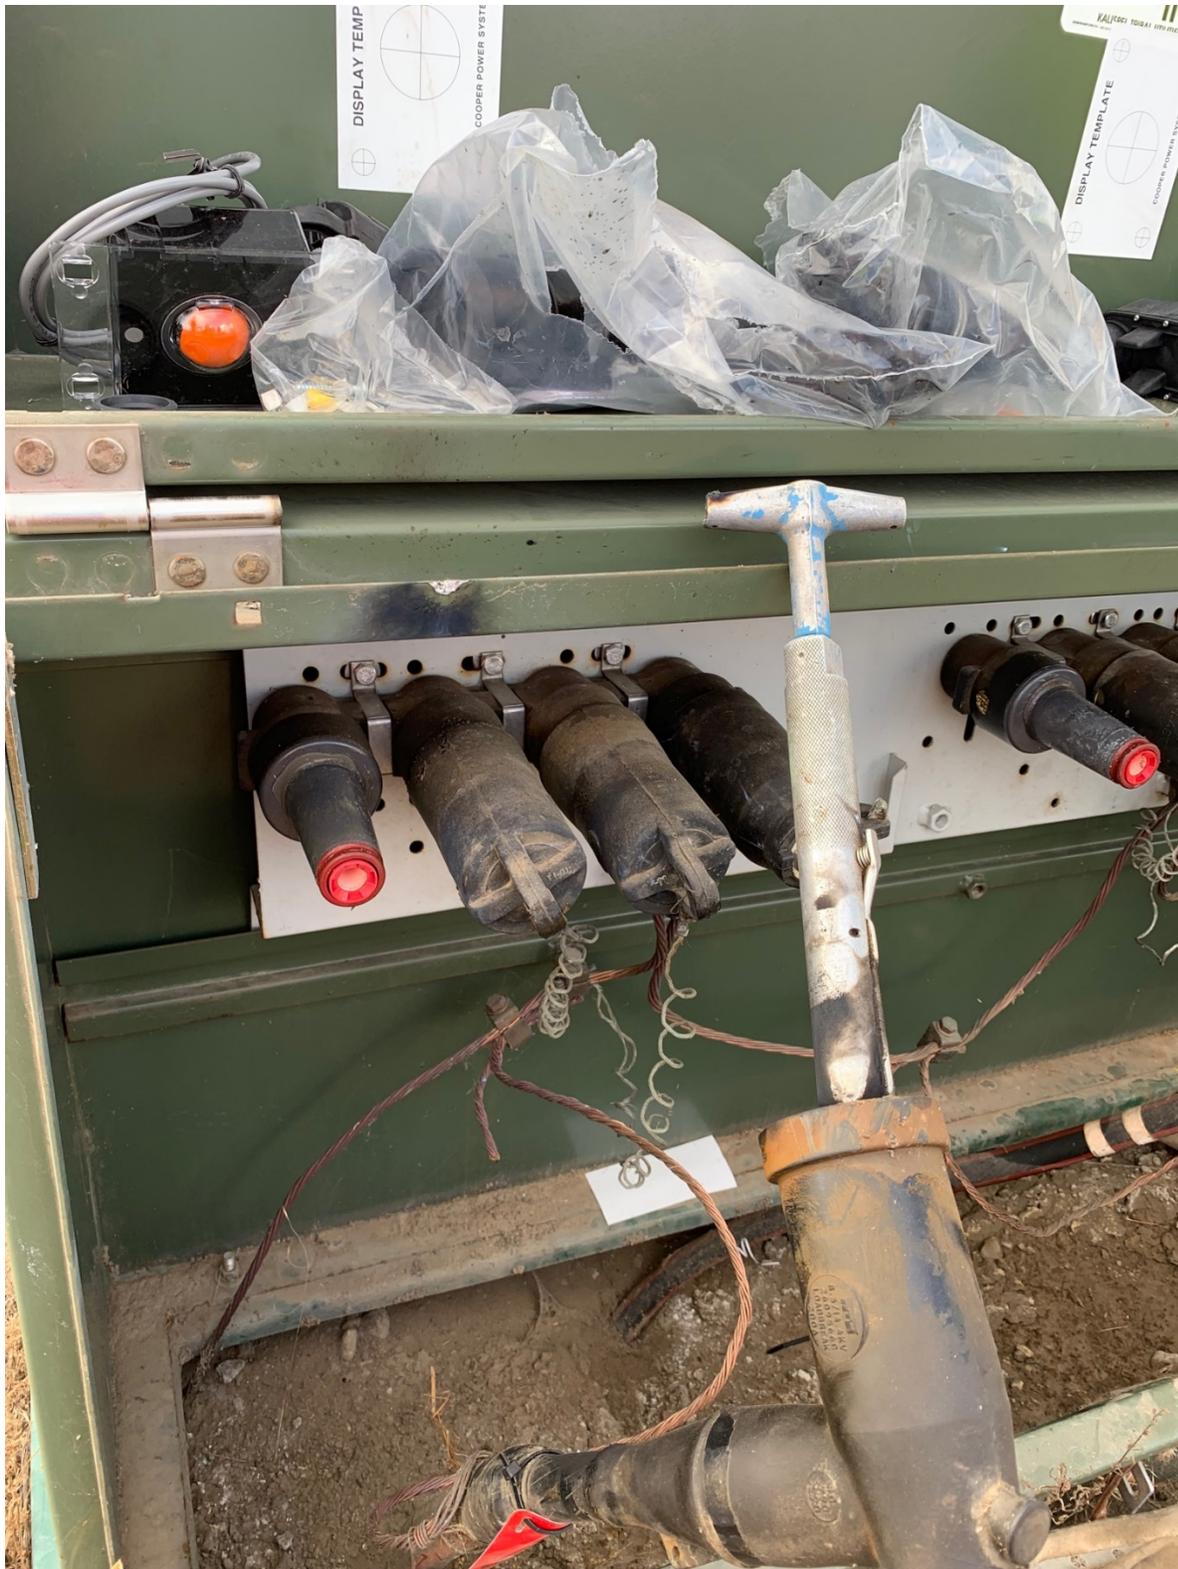
Probe tool in the A phase elbow at Junction Enclosure #3
