Puget Sound Energy
Accident Report
September 6th 2016

Reported by

Dan Perron

Accident Investigator

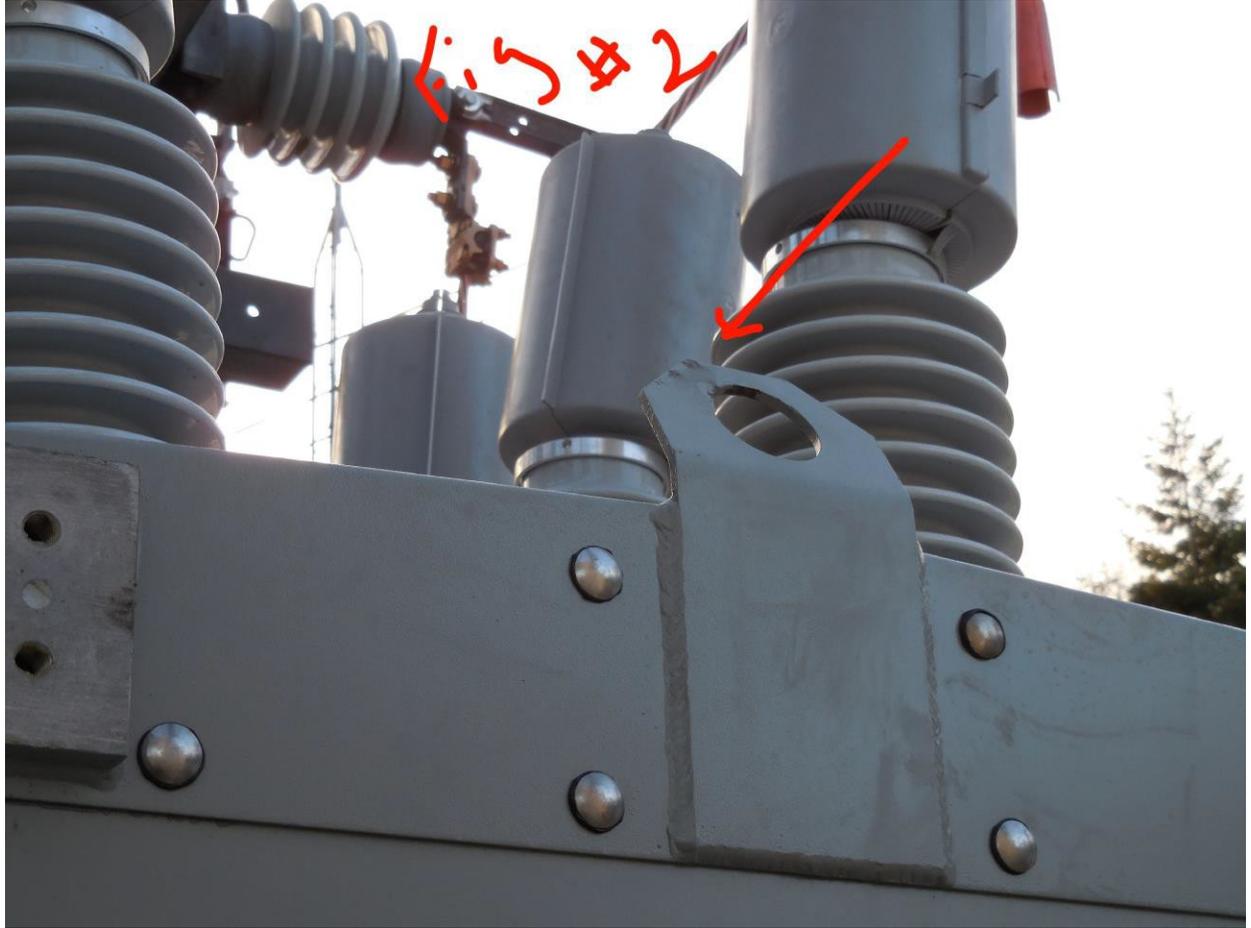
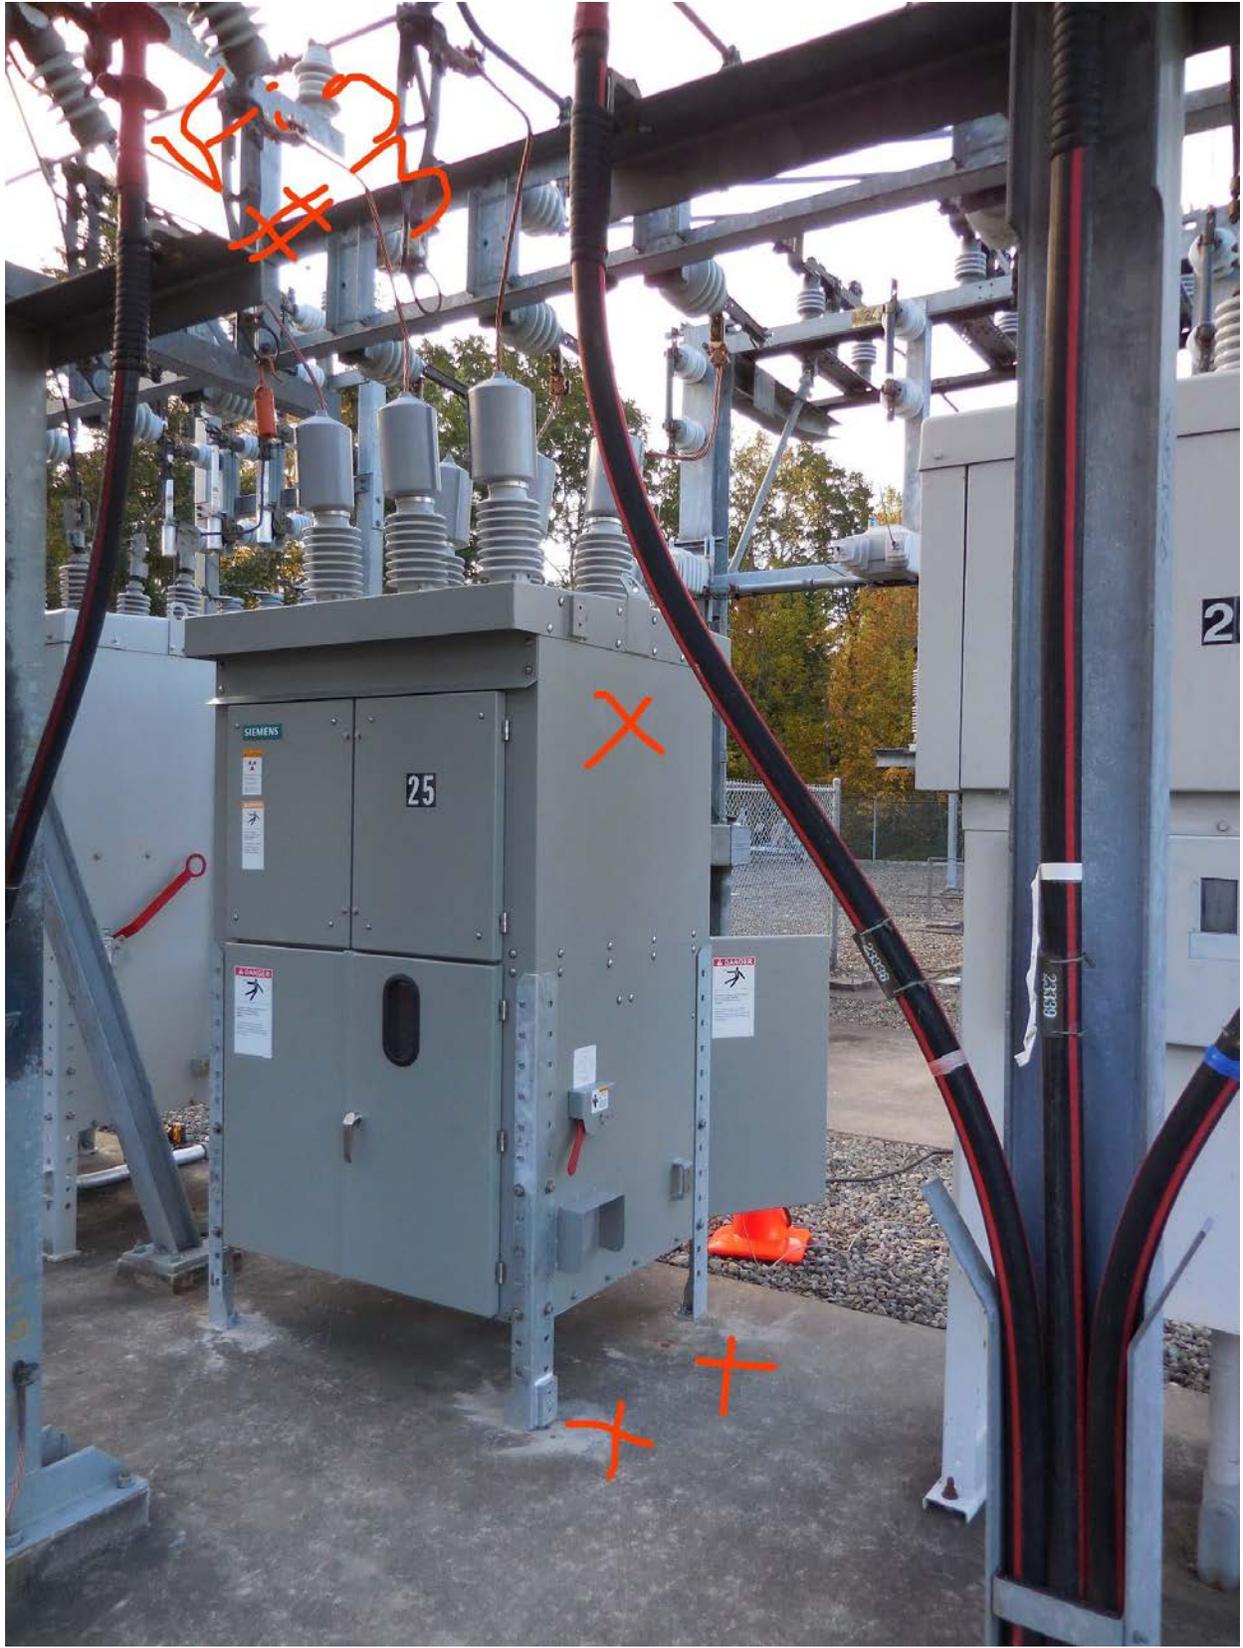
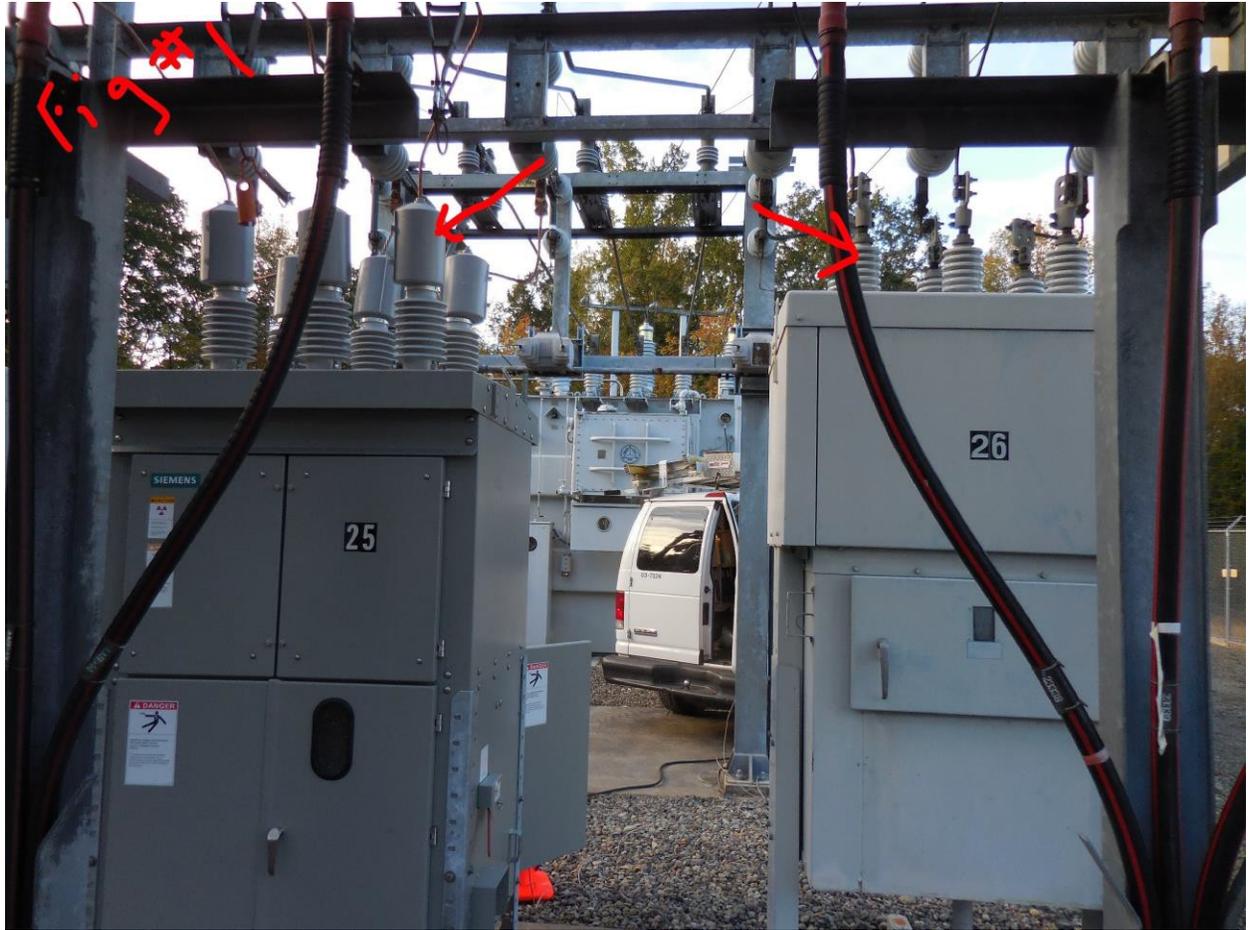
On September 6th 2016 at the Longmire Substation located in Yelm, WA a PSE sub crew was in the process of wiring a newly installed vacuum circuit breaker. The crew consisted of a Foreman, (2) Journeyman Wireman, an 8th step Hot Wireman Apprentice, and (2) 1st step Wireman Apprentices. Substation voltage of 115kv/12.5kv. The VCB the crew was working on was a brand new install it had never been energized, just put in place and bolted down. The task at hand when the accident occurred was to install paddles on the source and load side bushings on the top of the VCB for the permanent connections. In the attached photos, equip. ID 25 is the new breaker, equip. ID 26 is an existing energized breaker. In figure #3 the two x's represent where the feet of the fiberglass ladder were placed and the x on the cabinet where the 8th step apprentice's working position was on the ladder in order to reach the bushings that in the picture are now under squirrel covers. VCB 25 had no grounding cables or conductors of any kind attached yet as it had never been energized. The crew was discussing which direction the paddle, bolts and nuts should face. The 8th step apprentice had his left hand on the picking point of the VCB 25 (fig #2) and swung his right arm out straight with a metal paddle in his right hand to point out the paddle alignment on VCB 26. When he did this the paddle came close enough or made contact with the energized bushing of VCB 26 (fig. #1). Close enough for the apprentice to be electrocuted, he fell from the ladder and hit his head on the concrete pad. The apprentice was transported via ambulance to St. Peters Hospital in Olympia stabilized and transported to Harborview. He was kept for observation for 24 hrs. and released, he has burns on the inside of his hands, possible concussion, and could have any of the post effects of an electrical contact. The crew stated that there was caution tape a couple feet from ground level around the breaker, and that they had frequently talked about the fact that there were energized breakers, bushings, and bus around their work area. The only reference to ground for the case of VCB 25 were the anchor bolts holding the legs of the case to the pad.

Preventative measures to avoid this accident:

cover, rubber blankets, insulator hoods, barricades

Be aware of reach or falling for incidental contact from working position.
